Intel386™ EX Embedded Processor

Specification Update

July 1998

Order Number: 272873-009

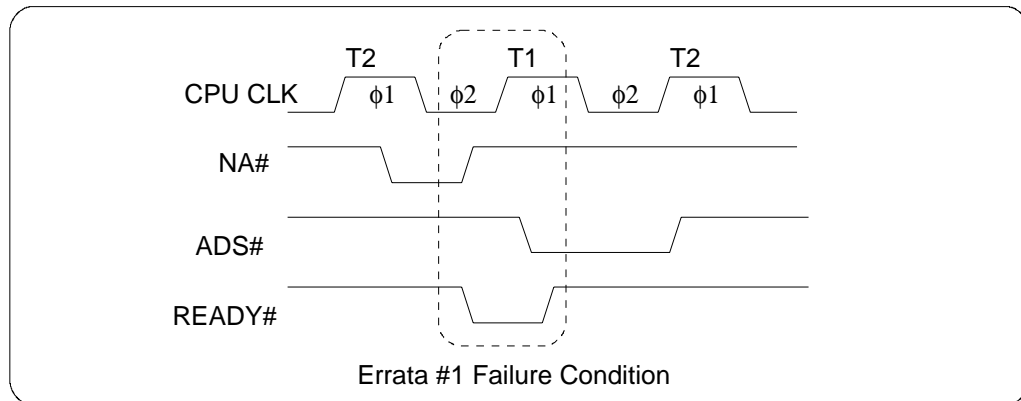
1. Watchdog Timer (WDT) Bus Monitor Failure During Bus Pipeline Operation

Problem: The errata applies to the WDT unit when using the Bus Monitor Mode and Bus Pipeline operation. If a pipelined bus cycle is requested at the same time the current bus cycle is completed, the WDT down counter is not reloaded or stopped. This condition means that the WDT could time-out and erroneously report a system failure. The waveform below shows the errant condition.

The errata condition is caused by the system generating READY# immediately after NA# has been requested, and a T1 cycle is generated (rather than a T2P cycle). Essentially, the system is requesting a pipelined access, but does not need it because READY# has been returned. Such a condition is not typically expected when using the pipeline feature.

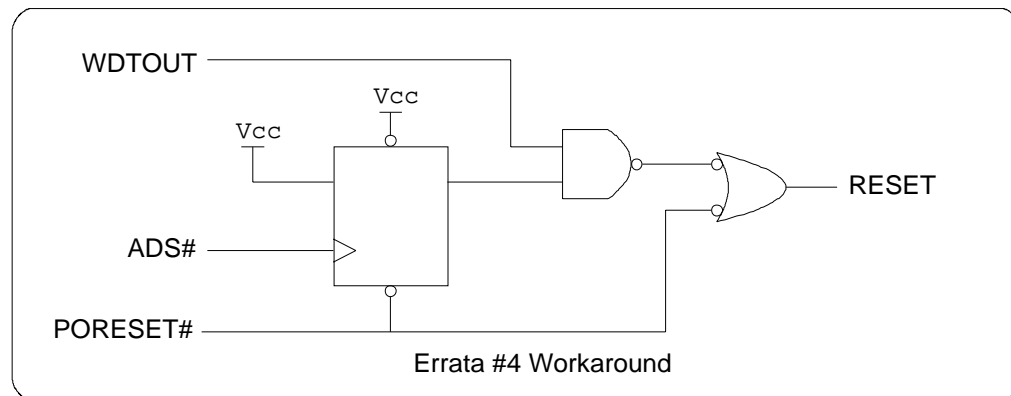
Implication: This errata only applies to a system design that uses the WDTOUT signal to generate a device reset. The WDT will time out and reset the device before the CPU self-test can complete.

Workaround: The WDTOUT signal cannot be directly tied to the RESET input during self-test since there is no mechanism to increase the default value loaded into the WDT counter. The circuit shown below can be used to block WDTOUT until the first ADS# is generated. The signal PORESET# is a power-on reset signal generated by the system. WDTOUT is an output of the Intel386 EX processor, and RESET is an input to the processor. Please note that the circuit below has not been tested in a real design and is provided as an example only.

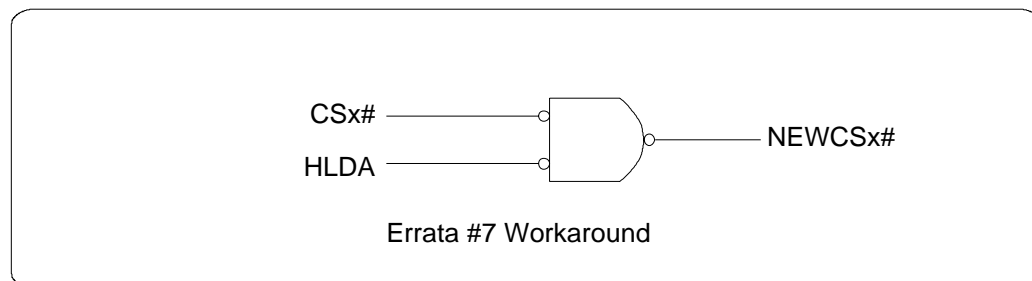
Problem: When the device enters a bus HOLD state because of a HOLD or DMA Cascade operation, the Chip Select that was valid in the previous cycle can remain active during the bus hold. This can cause bus contention when another bus master gains control of the bus.

Workaround: Qualify a chip-select with HLDA such as shown in the circuit below. The chip-select will go inactive if HLDA goes active. If using a PLD device, then HLDA should be used to qualify the chip-select as shown in the following diagram.

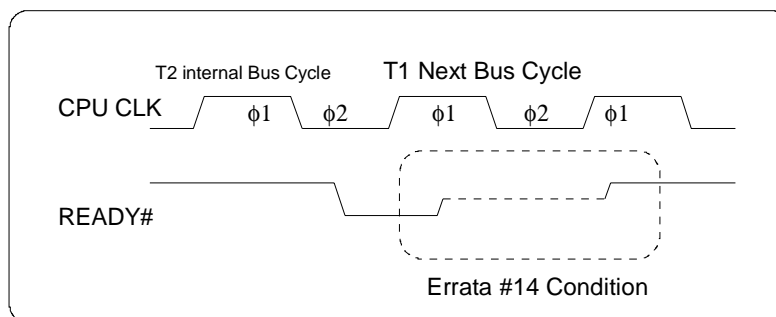
14. READY# Floats In T1 After Internal Bus Cycle Due to LBA#

Problem: During internal bus cycles, the LBA# signal does not remain active into the next T1 bus state, causing READY# to float during T1. This is unlike bus cycles controlled by the Chip Select Unit (CSU), where READY# is driven inactive during T1 of the next bus cycle.

Workaround: Pull-up READY# if the float condition will cause system logic to operate improperly.

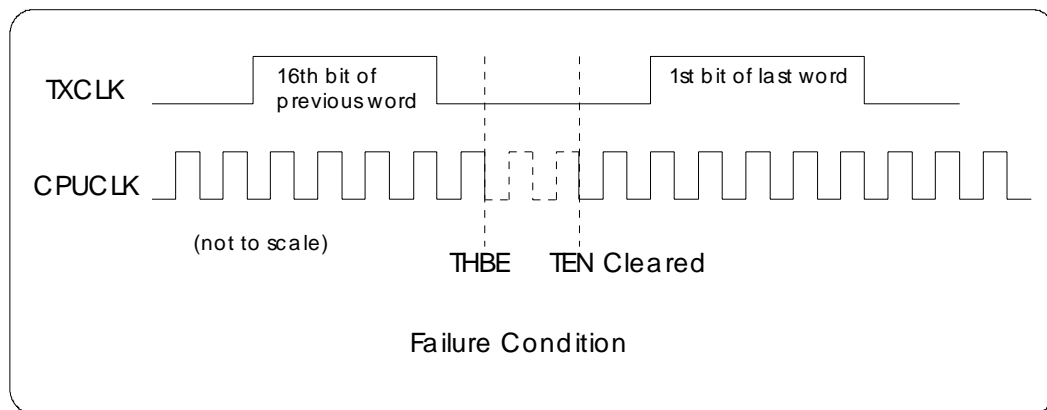
If the TXCLK is significantly slower than the CPUCLK, it is possible for the THBE bit to be set and the TEN bit to be cleared all during the low time of the TXCLK (see diagram). In this case, even though the last word to be transmitted has been loaded into the shift register, it will not be shifted out.

Workaround: In order to assure that the last word is transmitted, the TEN bit must not be cleared until after the TXCLK transitions from low to high when the 1st bit of the last word is being transmitted. Consequently, the way to assure that this happens is to either: 1) utilize a timer to assure that enough time elapses from when the THBE bit goes high until the TXCLK goes high, or 2) execute a fixed number of NOPs after THBE goes high before clearing TEN. In either case, the length of the delay is dependent upon the frequency of TXCLK and the CPUCLK.

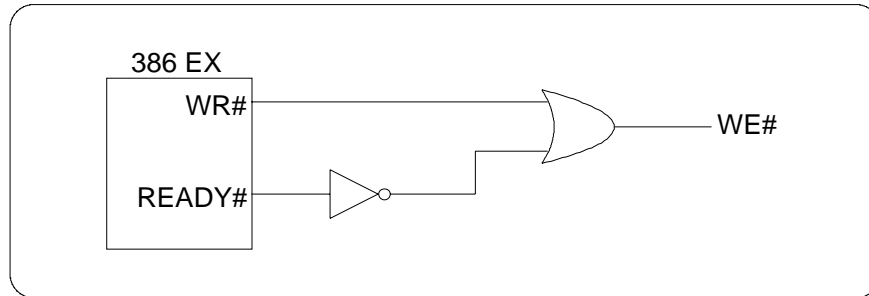
Implication: This errata applies to all applications that use the WR# signal as the write strobe to memory or I/O.

Workaround: The circuit shown below may be used to generate a write strobe if the READY# signal is not generated too early in the T2 cycle. Please note this circuit has not been tested in a real design and is provided as an example only. For applications which cannot use the circuit below it is necessary to implement an external WE# signal using a simple state machine design. An example of what that state machine could look like is available in the EV386EX evaluation board design, or in the Point of Sales Terminal reference design available from the WEB, BBS or through literature.

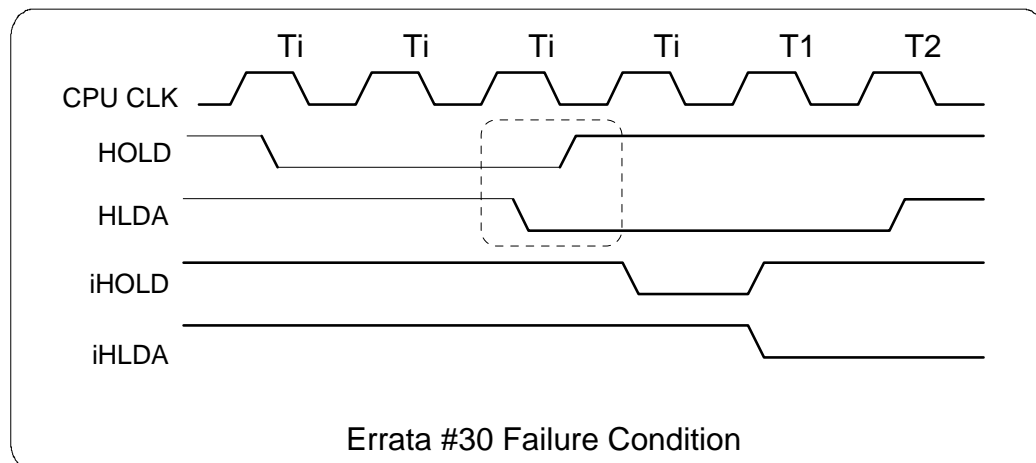
30. HLDA Inactive To HOLD Active Arbitration Could Improperly Float The Bus

Problem: In a HOLD/HLDA cycle the HOLD signal must not be re-asserted until after HLDA is returned inactive. If, however, HOLD is asserted in the same T-state that HLDA goes inactive a problem may occur where the bus arbiter relinquishes control to the core and at the same time floats the bus by asserting the HLDA pin. The following waveform shows the conditions that cause this error. The signals iHOLD and iHLDA are internal signals and represent the HOLD input to the core and the HLDA output from the core (equivalent to the HOLD and HLDA signals on a Intel386™ SX processor). In this diagram a T1 occurs because a request was pending by the core during the previous HOLD cycle. One T-state after the arbiter releases the bus (HLDA = 0) it removes its iHOLD, and then the core removes iHLDA. As soon as the iHLDA is released, the T1 state starts. However, because of the timing of the next HOLD request, the bus arbiter re-asserts iHOLD and HLDA even though the core has not asserted iHLDA. The result is that the core continues to run its bus cycle and, at the same time, the bus arbiter has floated the external bus. It is also possible for the following to occur when HOLD/HLDA arbitration is at issue: HOLD is driven active during the T1 or Tw of a valid bus cycle. The processor begins the next bus cycle and generates HLDA. HLDA is active for only one T-state. ADS# is extended through the bus cycle. The alternate bus master sees the HLDA and performs its bus activity. HOLD is then driven inactive and the bus is returned to the Intel386™ EX Processor. At this point there is bus contention.

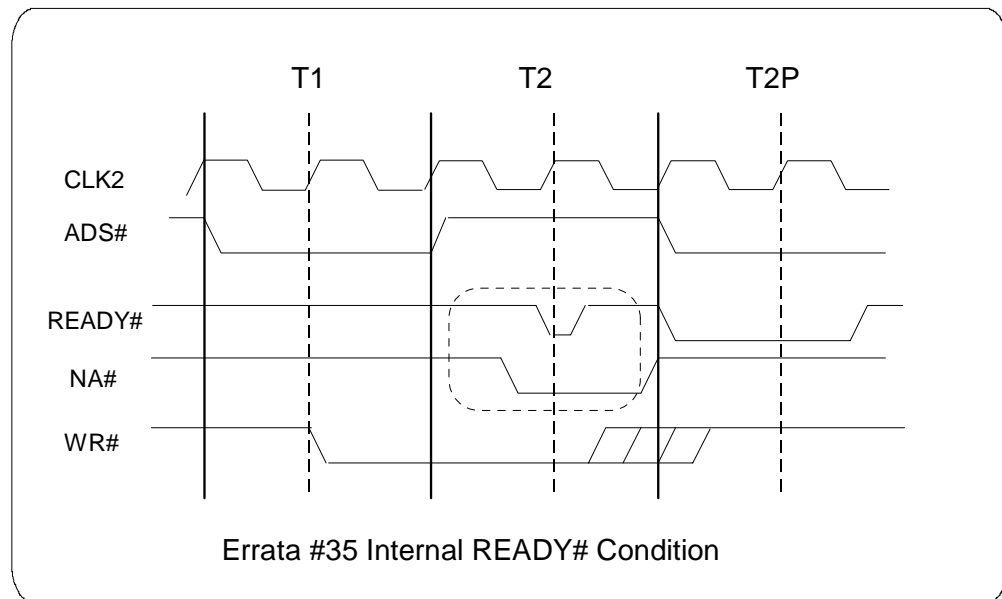
Implication: This errata applies to all applications programming zero wait states on chip select and generating an internal READY#. The temporary transition of READY# will only occur when switching from non-pipeline to pipeline mode.

Workaround: None. Do not trigger any external state machine on asserted READY# signal in T2 unless it occurs at the end of the T2 state where expected.

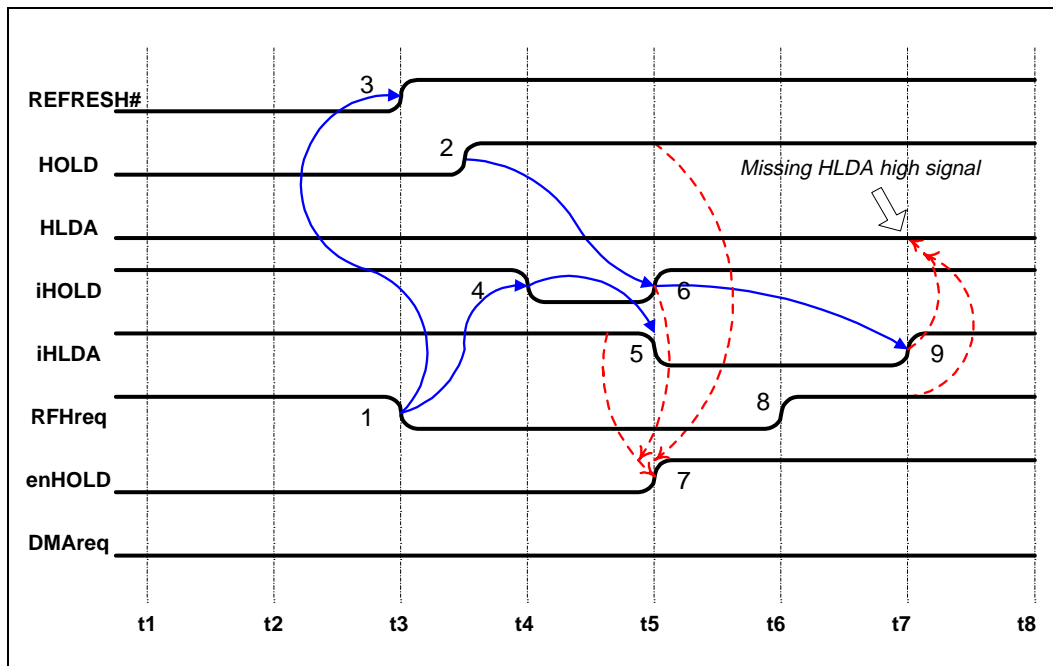
Figure 3. HOLD with Short REFRESH Interval

1. For system designs that use both HOLD and the internal Refresh Control Unit, the conditions are as listed in a, b, and c.
 - a. A small RFSCIR register value can cause the current refresh cycle and the next refresh cycle to almost overlap. Refer to Figure 3. When such a condition exists, there is a possibility that the refresh latency will cause a gap between the current refresh terminating (t3) and the next refresh (t6). This will create a problematic window if HOLD is asserted during that time. The minimum RFSCIR count that can be used without causing this problem depends on HOLD latency which is related to bus activity. HOLD latency is similar to refresh latency since they both generate an iHOLD request to the core. HOLD latency is basically a factor of wait states, locked cycles and special cycles such as interrupts. Worst case conditions should be used and can be calculated based on the information on page 6-37 (Hold Signal Latency) of the Intel386™ EX Embedded Microprocessor User's Manual (order number 272485-002). If the RFSCIR is a few cycles longer than the maximum calculated HOLD latency plus refresh duration, the problematic window will not exist. This condition should not happen in a typical customer design, since the RFSCIR value is usually larger than the worst case minimum value. To avoid this error, no workaround is needed as long as the RFSCIR value is greater than the recommended minimum value. The minimum RFSCIR can be roughly calculated as follows:

Figure 3 shows Condition #1a where an external HOLD and refresh request conflict can occur. The table below describes each signal name used:

Workaround: If the situations listed in conditions #1 and #2 cannot be avoided, the user needs to synchronize the external HOLD request such that it does not go active in an idle bus cycle or a refresh cycle. Alternately, HOLD can be deasserted if a HLDA is not received within a time-out period, as described in workaround 2. A third listing describes another recommended workaround when using HOLD, DMA, and REFRESH.

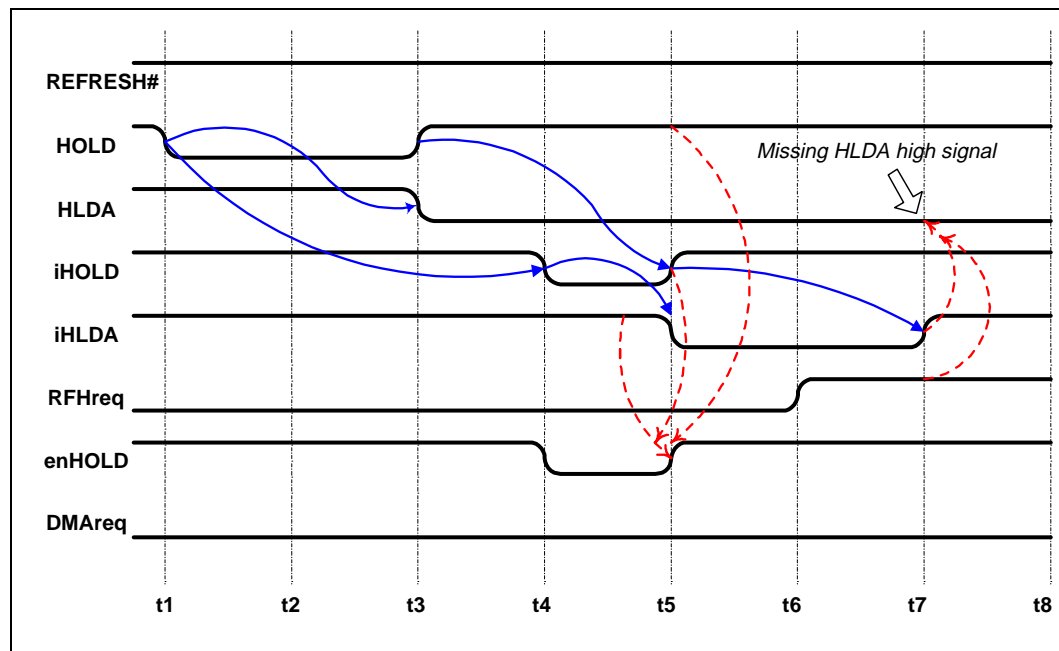
Figure 4. Quick HOLD Assert and Deassert with Slow REFRESH Interval

- b. HOLD is removed and reasserted within one bus cycle. Refer to Figure 4. This condition will cause the problematic window with fast iHOLD deassertion (t4) and assertion (t5). Note that if HOLD is deasserted because of pending REFRESH and reasserted again within one bus cycle, the problem will not occur since the iHOLD signal is never deasserted due to refresh. The reassertion of the HOLD would then be serviced upon completion of the refresh.

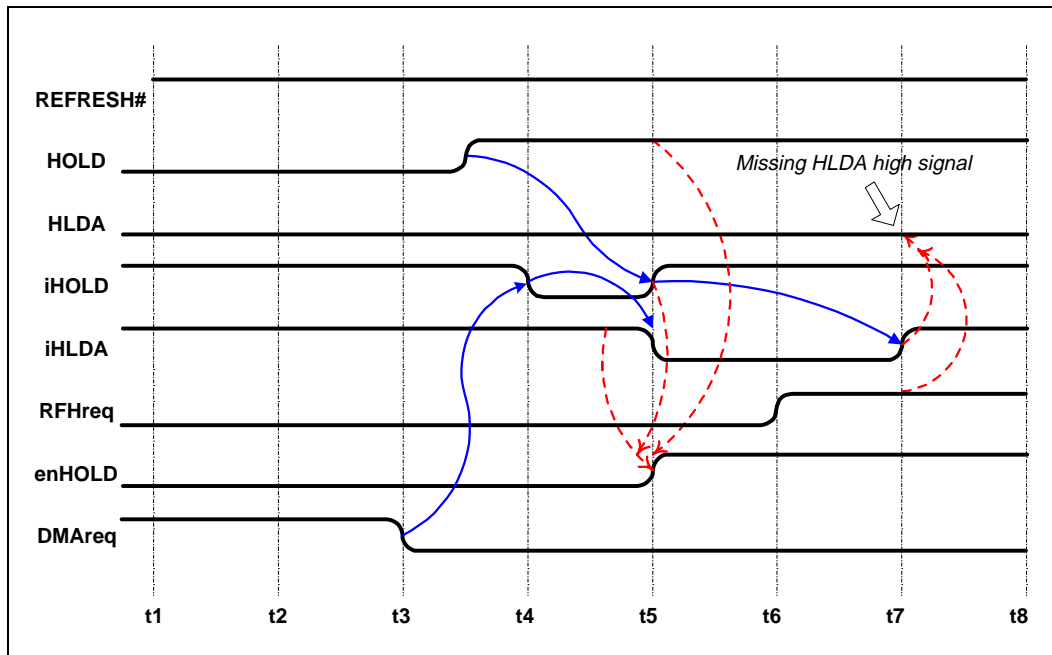
Figure 5. DMA, HOLD and REFRESH with Normal Interval

2. For system designs that use DMA, HOLD and REFRESH.

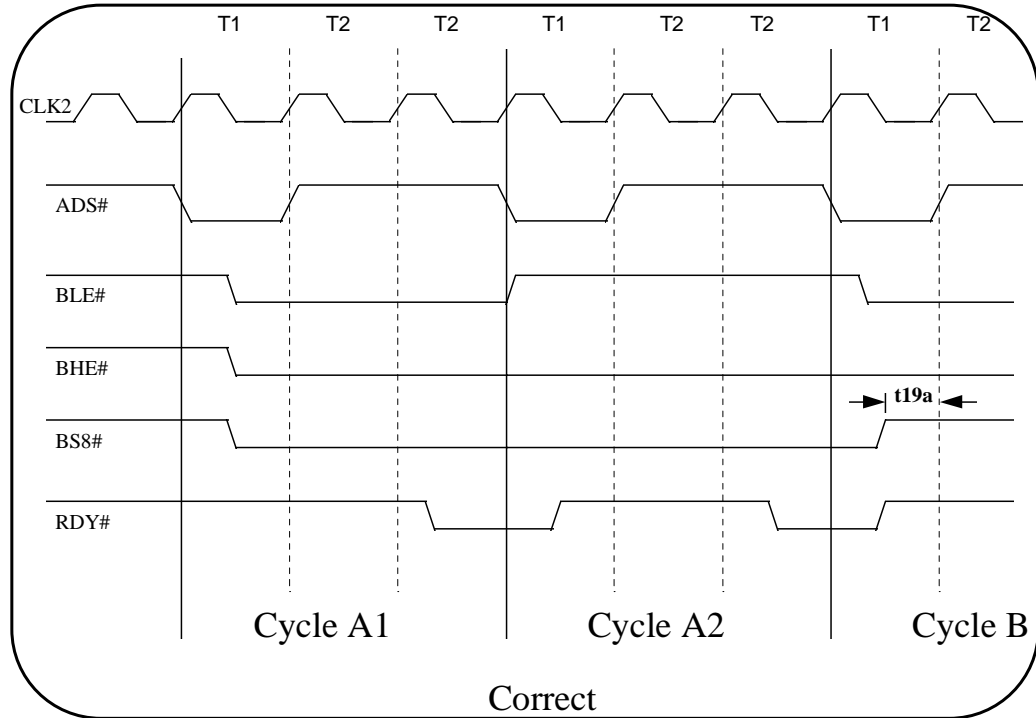
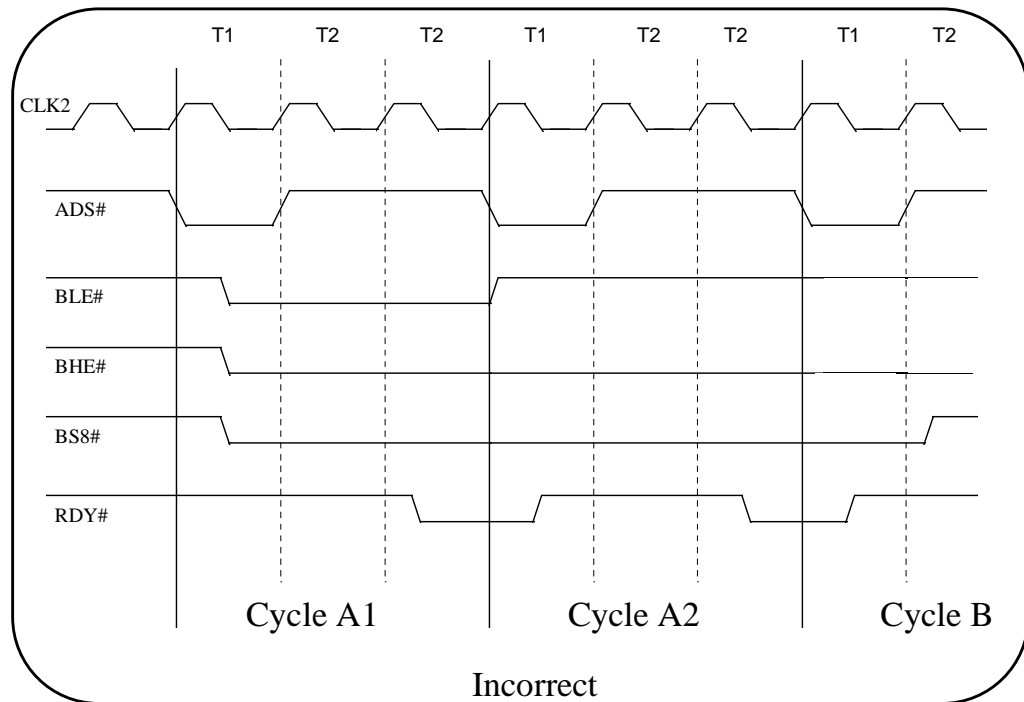
The reason this occurs is as follows: the processor latches the state of BS8# at the beginning of the first T2 of CYCLE B (to perform byte-steering within the processor) and resets this latch only in the next T1 or T1 state. Therefore, if BS8# is kept active into the first T2 of CYCLE B, then the byte-steering logic of the processor incorrectly assumes that CYCLE B is also a cycle to an 8-bit device. This causes the bytes to end up on the wrong data path.

Here are example waveforms demonstrating incorrect vs. proper latching of BS8#:

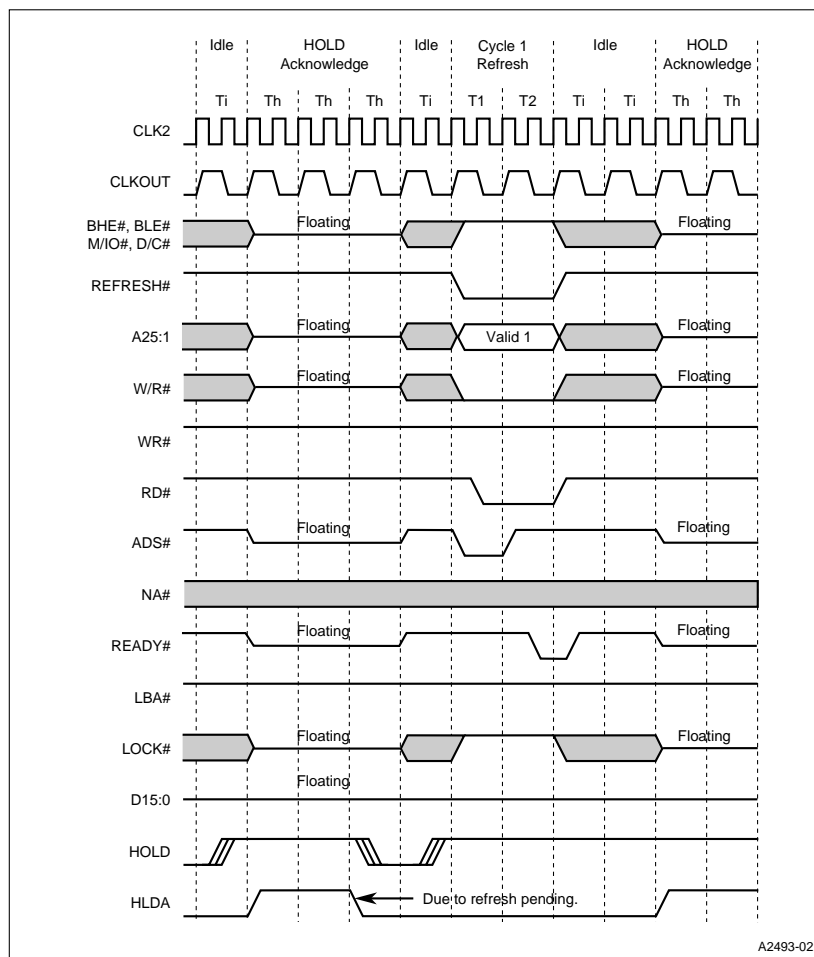
11. 272485-002, Section 6.3.6, Page 6-30, Figure 6-12.

Issue: Modified the ADS# and READY# waveforms to indicate floating. The corrected figure is shown below.

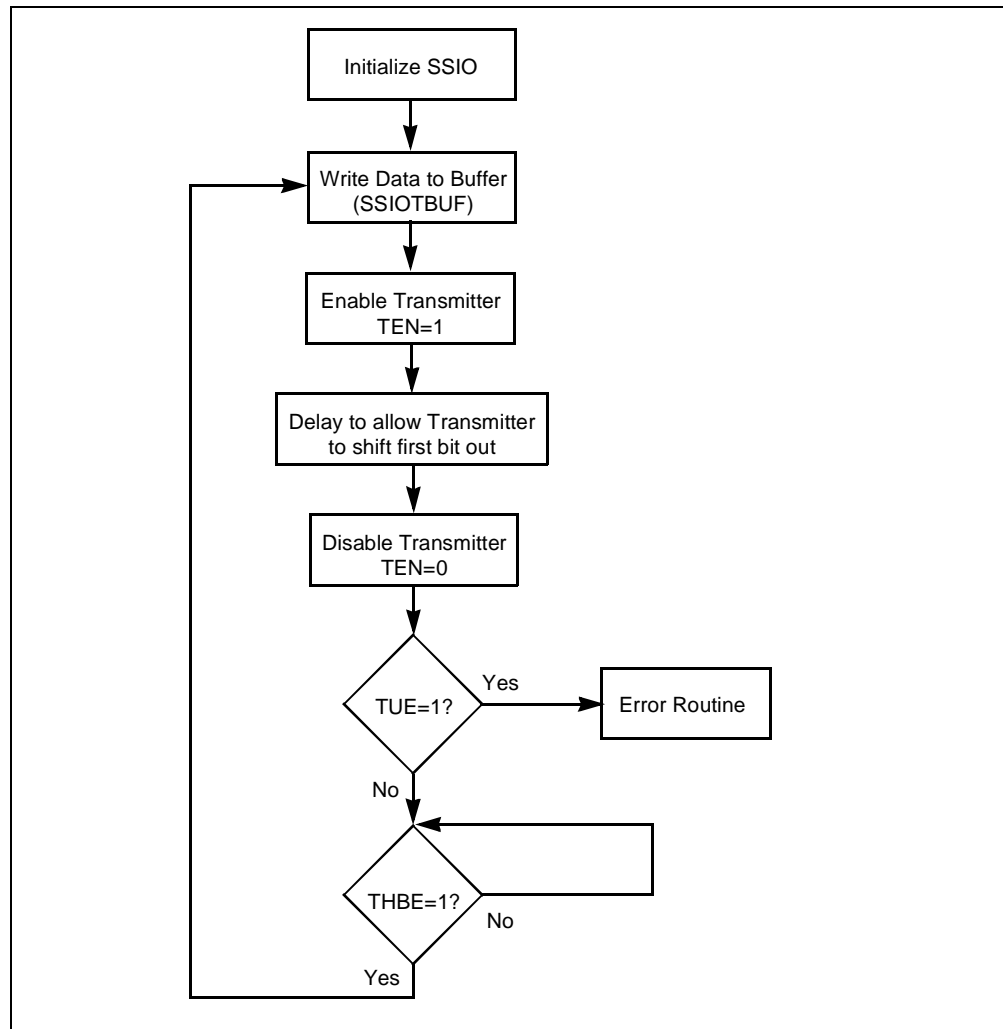
Figure 11. Transmit Data by Polling

Issue: Replace figure 13-8 with Figures 13-8a and 13-8b as shown below.
