TC1775

32-Bit Single-Chip Microcontroller

TC1775 Documentation Addendum

Revision History: **2001-10**

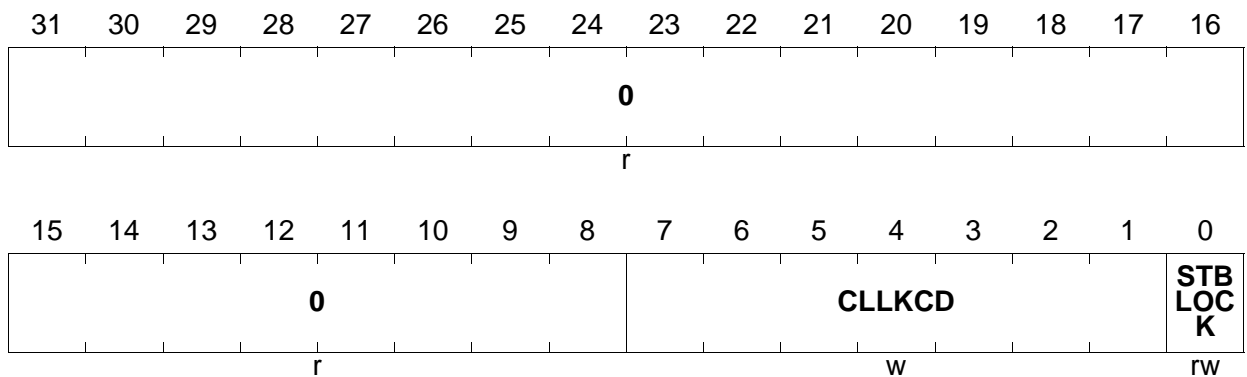
DMU_CON
DMU Control Register **Reset Value: 0000 0000_H**

The description of register DMU_CON must be corrected in the following way:

¹⁾ This bit field is not available in the TC1775 BA11 step.

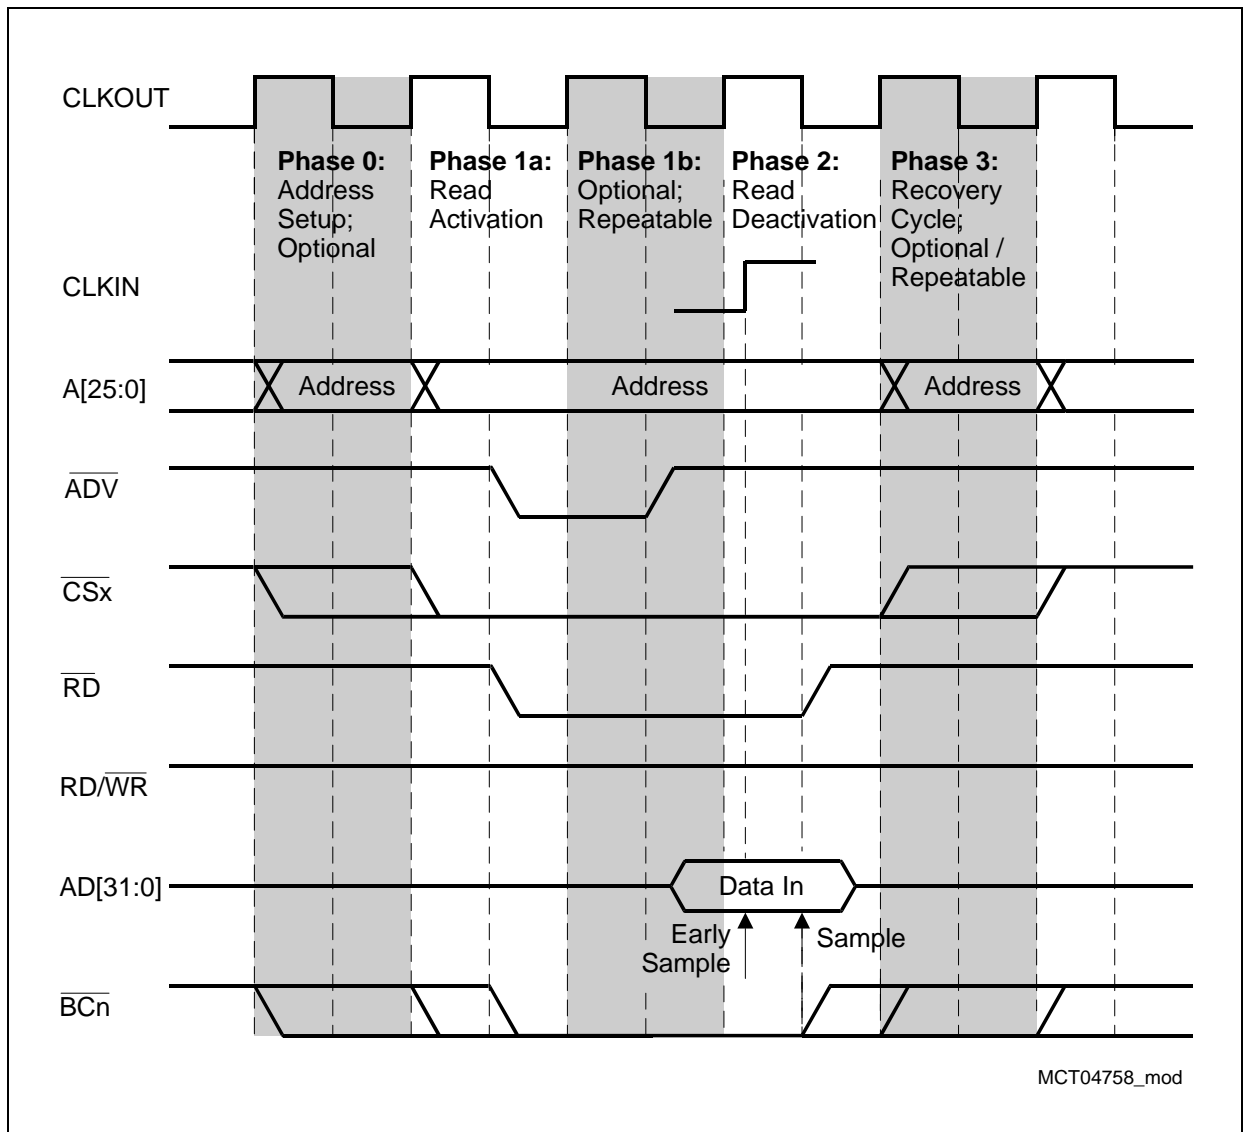
Figure 12-6 Basic Read Access Timing in Demultiplexed Mode

The TC1775 provides an additional demultiplexed read timing feature called "Early Sample". This feature is shown in the corrected **Figure 12-6** and controlled via bit 26 (called ES for "Early Read Sample Select") in register EBU_BUSCONx. EBU_BUSCONx.ES must be added as described on **Page 9**).

- "Phase 2: This cycle is always part of a read access. Please note that the read signal is deactivated (high) on the falling edge of CLKOUT. The data input is sampled and latched with this clock edge (EBU_BUSCONx.ES = 0) or with the rising edge of CLKIN when early sample is enabled with EBU_BUSCONx.ES = 1."
