# TC1775

## 32-Bit Single-Chip Microcontroller

## TC1775 Documentation Addendum

**Revision History:**            **2002-07**

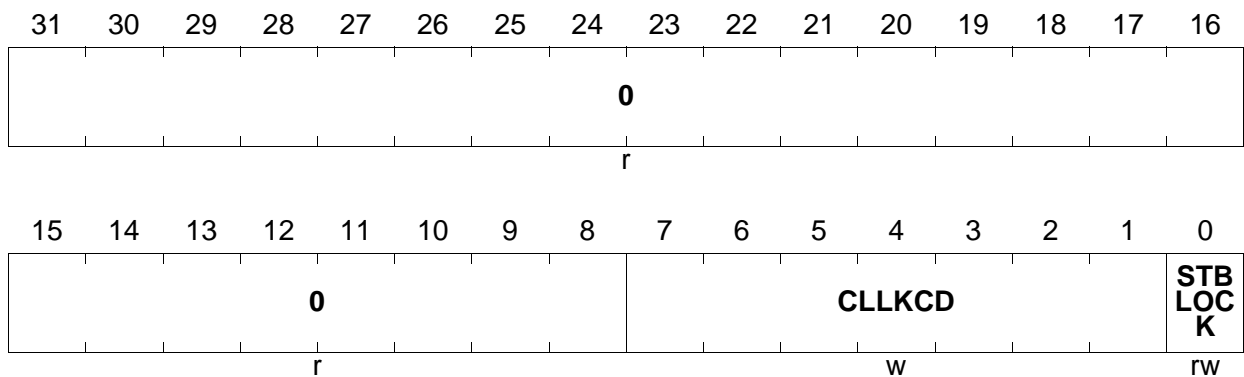
**DMU\_CON**

The description of register DMU\_CON must be corrected in the following way:

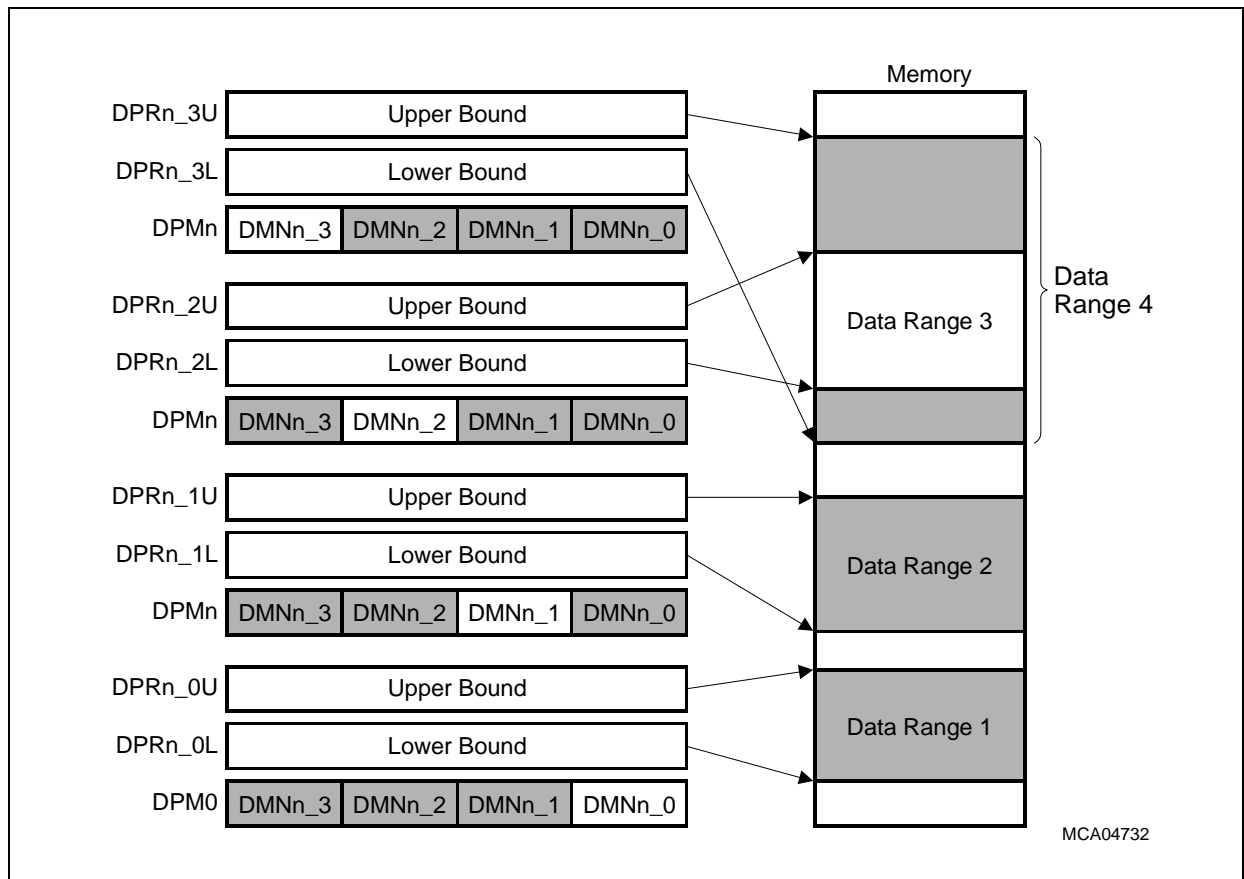
**Figure 10-2 Example Configuration of a Data Protection Register Set**

The Data Range numbering in **Figure 10-2** is not correct. The figure must be updated in the following way:

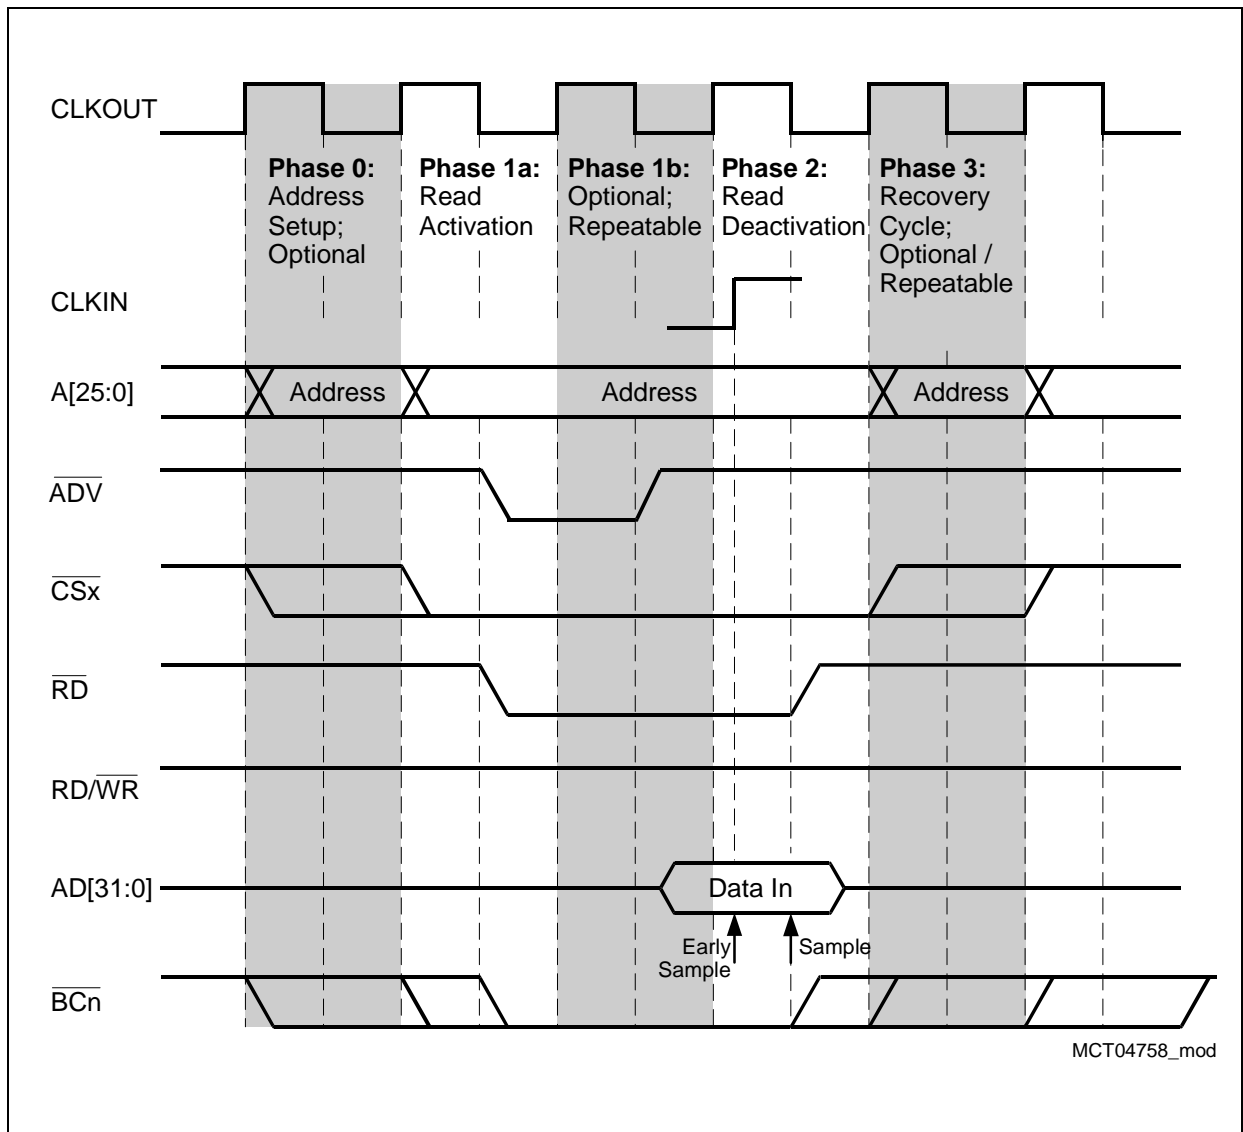
Figure 12-6 Basic Read Access Timing in Demultiplexed Mode

The TC1775 provides an additional demultiplexed read timing feature called “Early Sample”. This feature is shown in the corrected **Figure 12-6** and controlled via bit 26 (called ES for “Early Read Sample Select”) in register EBU\_BUSCONx. EBU\_BUSCONx.ES must be added as described on **Page 10**).

Due to this new feature, the paragraph starting with “Phase 2: ...” on page 12-21 must be replaced by the following description:

- “Phase 2: This cycle is always part of a read access. Please note that the read signal is deactivated (high) on the falling edge of CLKOUT. The data input is sampled and latched with this clock edge ( $EBU\_BUSCONx.ES = 0$ ) or with the rising edge of CLKIN when early sample is enabled with  $EBU\_BUSCONx.ES = 1$ .”

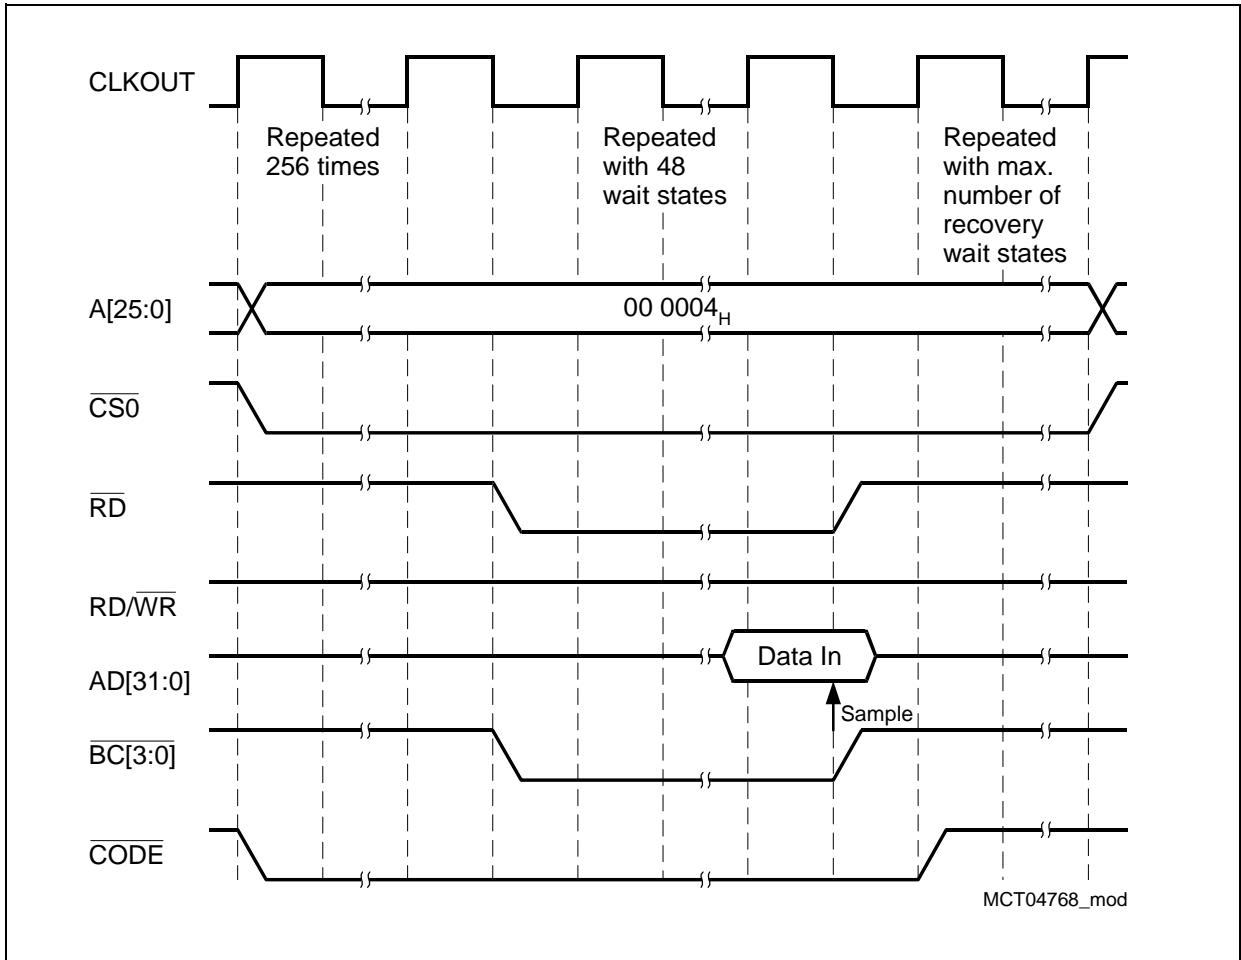
**Figure 12-16 EBU Boot Process after Reset**

Figure 12-16 should be update with the following drawing:
