TC1775

32-Bit Single-Chip Microcontroller

TC1775 Documentation Addendum

Revision History: **2003-02**

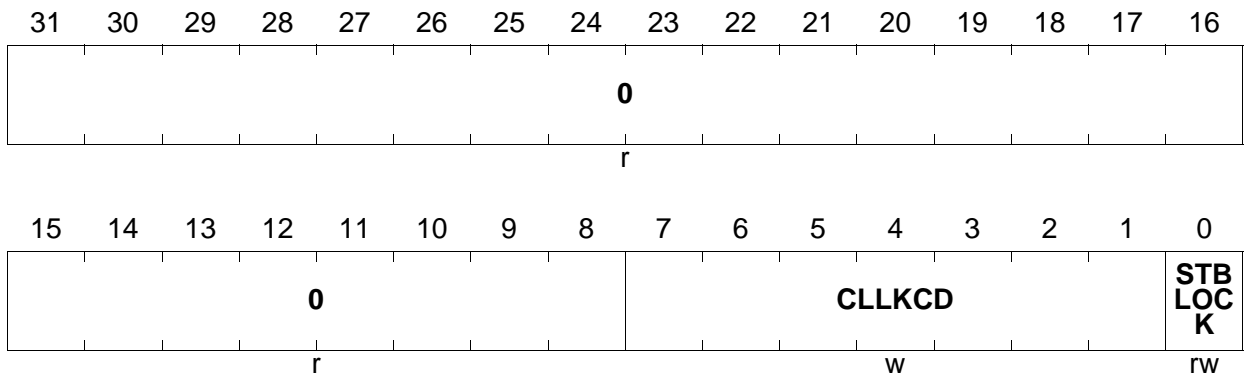
The description of register DMU_CON must be corrected in the following way:

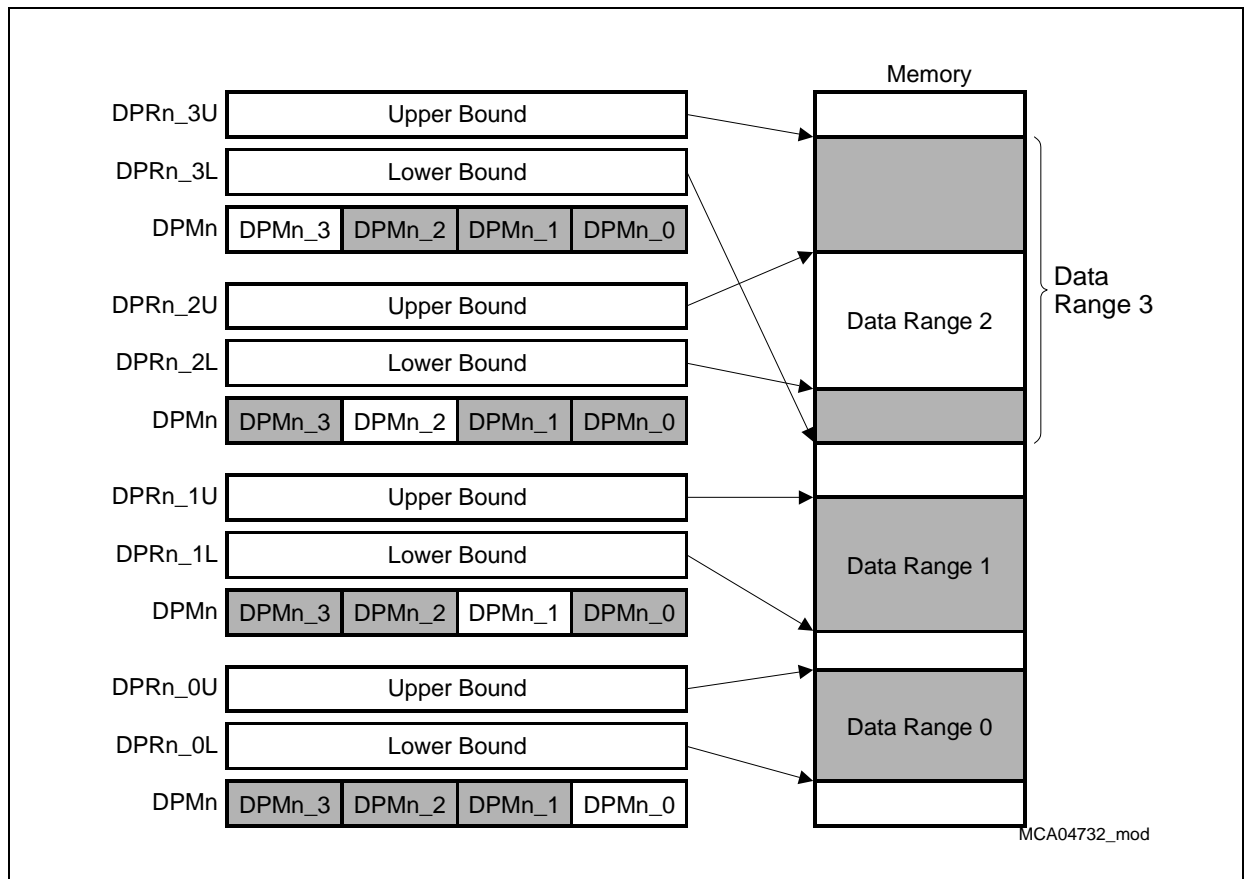
Figure 10-2 Example Configuration of a Data Protection Register Set

The Data Range numbering in **Figure 10-2** is not correct. The figure must be updated in the following way:

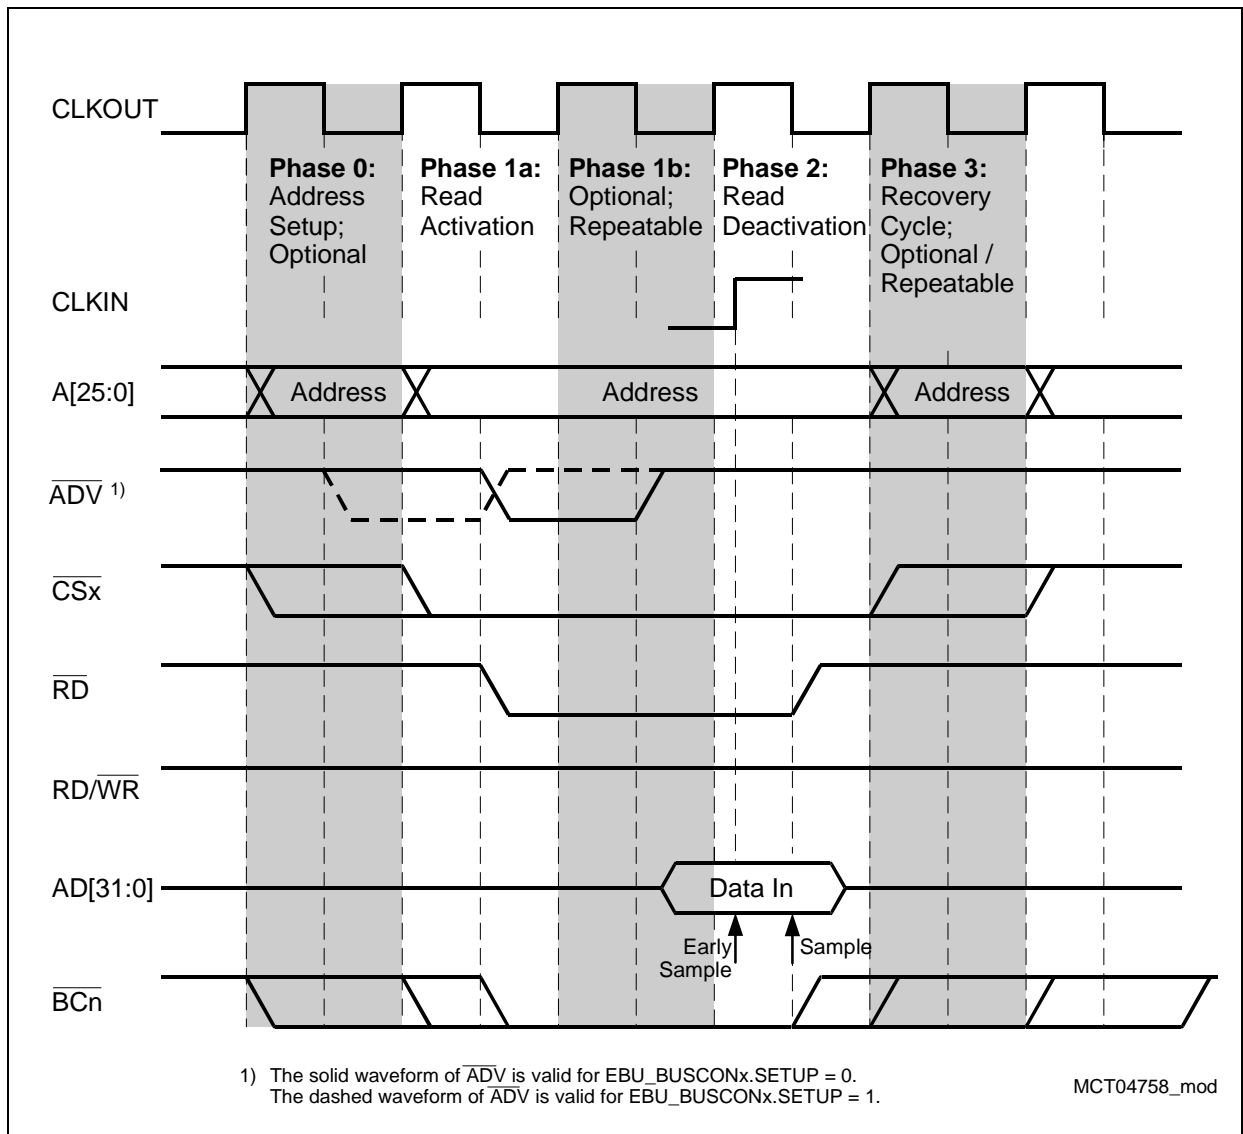
Figure 12-6 Basic Read Access Timing in Demultiplexed Mode

The TC1775 provides an additional demultiplexed read timing feature called “Early Sample”. This feature is shown in the corrected **Figure 12-6** and controlled via bit 26 (called ES for “Early Read Sample Select”) in register EBU_BUSCONx. EBU_BUSCONx.ES must be added as described on **Page 12**).

Figure 12-6 and **Figure 12-7** are also corrected concerning signal \overline{ADV} . As shown in these two figures, the \overline{ADV} timing depends on the setting of bit $EBU_BUSCONx.SETUP$.

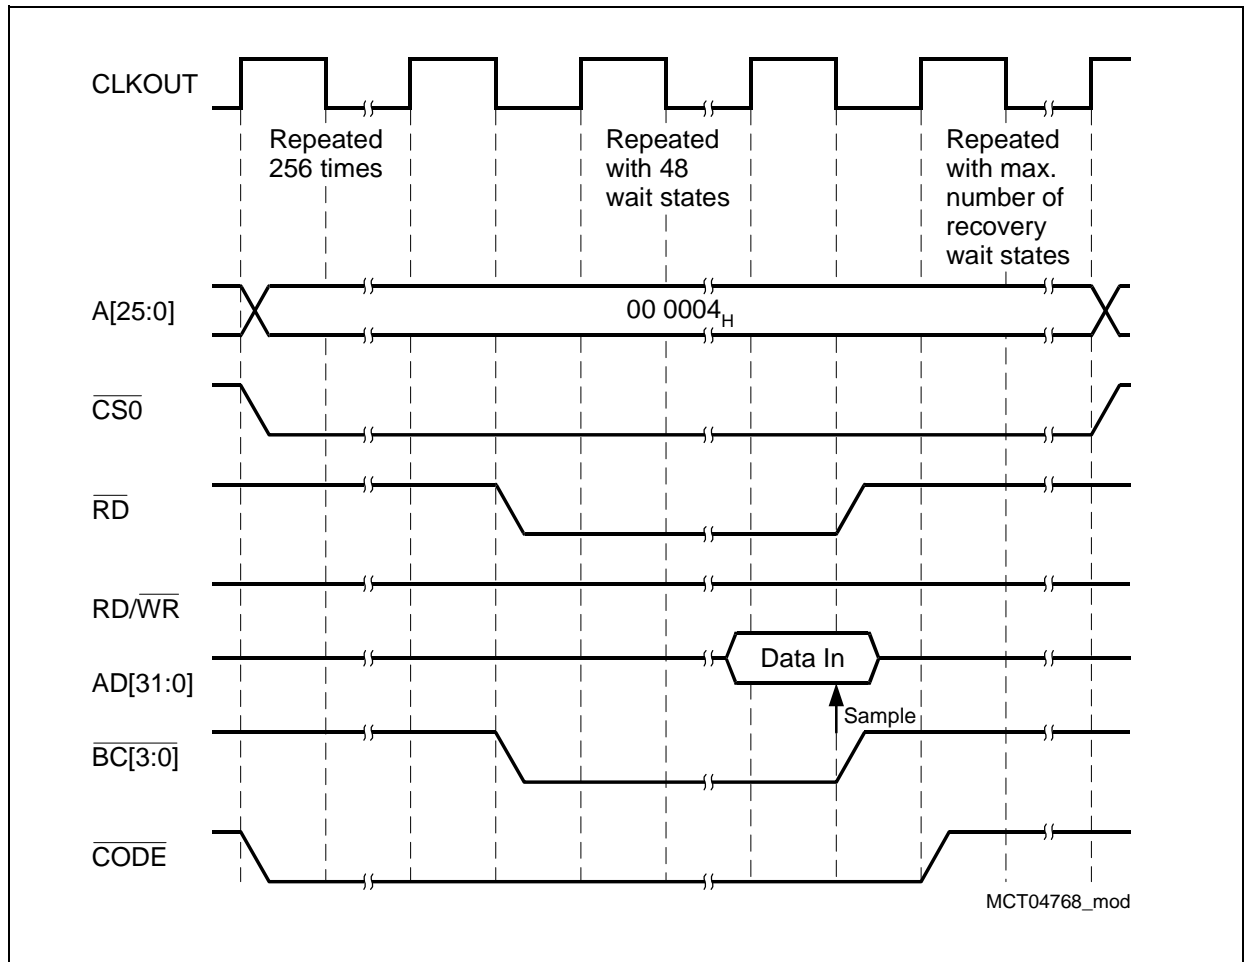
Figure 12-16 EBU Boot Process after Reset

Figure 12-16 should be update with the following drawing:

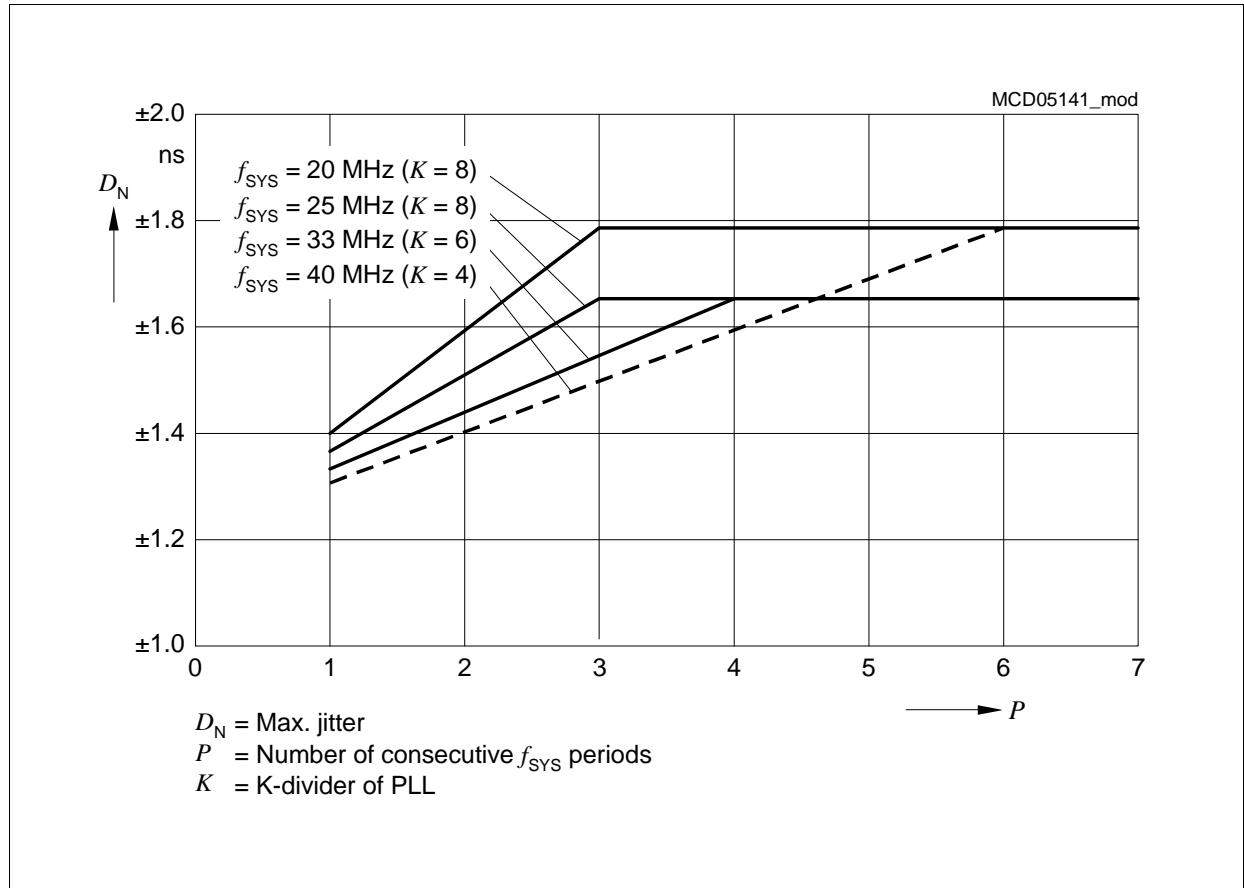
Figure 31 Approximated Maximum Accumulated PLL Jitter for Typical System Clock Frequencies f_{SYS}

Caused by the correction of Figure 31 on page 83, the last paragraph must be updated as follows: “Figure 31 gives an example for typical jitter curves with $K = 4$ @40 MHz, $K = 6$ @33 MHz, and $K = 8$ @20/25 MHz.”

Figure 31 must be corrected as shown below.
